Failure Analysis of Cracked Pipe-type Transmission Tower

W. S. Choi¹, N. K. Jung¹ and J. S. Kim^{2*}

¹Power generation division, KEPCO research institute, Daejeon, Republic of Korea

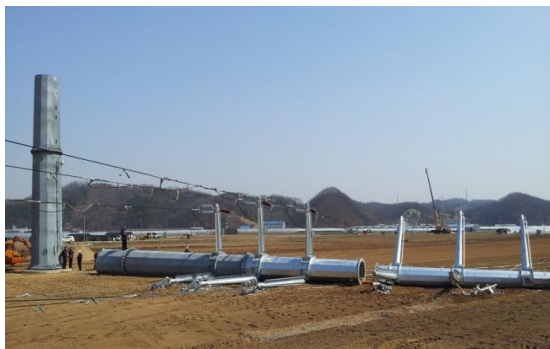
Fig. 1 Failure of pipe-type transmission tower

A large transverse crack with paint was found on the cross section of the welded part of the bottom of the transmission tower in which the accident occurred. The transverse cracks existing in the cross section of the steel tower in the accident are at a risk level because they are 95 mm length and exceeds the critical crack size of 40 mm, which is evaluated based on the fracture toughness of the material. As a result, the direct cause of the pipe-type steel tower failure is the transverse crack, which was present at the beginning.

It is well known that transverse cracks occur mainly in diffusible hydrogen and residual stress and in hardened material. In addition, it may occur depending on welding processes such as constraint, welding speed and heat input during welding, and transverse crack may occur even if residual stress is large. In the case of transverse cracks analyzed in this study, it is concluded that there is a defect in the welding process which is generated by welding with welding rod and welding condition which does not meet the standard. In the future, we will conduct actual load tests for representative types to evaluate the stability of initial micro cracks and partial penetration failure for the operation of reliable steel towers.

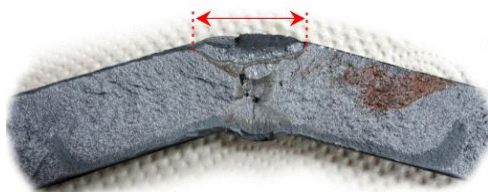
The specimen was taken from the damaged steel tower and analyzed. As a result, the seam weld line and the transverse crack perpendicular to the fracture section were observed. The cracks occurred simultaneously in the center welding layer and the inner welding layer of the welded section, not the parent material. Fig. 2 shows the traces of the paint entering the cracks of the heat affected zone facing the center of the weld bead and the roots on both sides.

Fig. 2 Transverse crack on the fracture surface

As shown in Fig. 2, there was already a visible crack on the surface of the inner weld bead before the finish coating on the inner surface of the steel tower, and the paint has flowed into the parent material part.

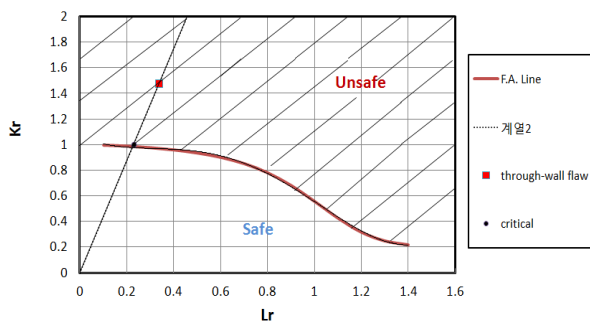
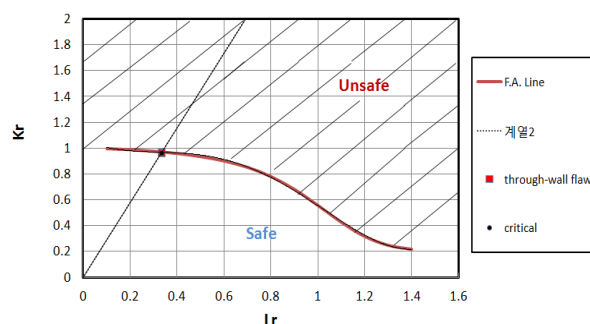
Fig. 5 FAD analysis results

(a) Critical load from FAD

(b) Critical crack size from FAD

Assuming a fracture toughness of $50\text{MPa}\sqrt{\text{m}}$, the crack size is 95 mm and the working load is 188 MPa. When the crack size is 95 mm, the critical load is 128 MPa. Therefore, when the working load of 188 MPa is fixed, the critical crack size is 40 mm and the pipe-typed tower is damaged due to transverse cracks in the weld.
