Failure Analysis of Tracked Vehicle Transmission and Recurrence Prevention

H. M. Baek¹, D. M. Park¹, K. Sohn¹, S. Won^{2*}, H. C. Ji³ and T. Kang⁴

¹Defense Agency for Technology and Quality, Changwon, Republic of Korea

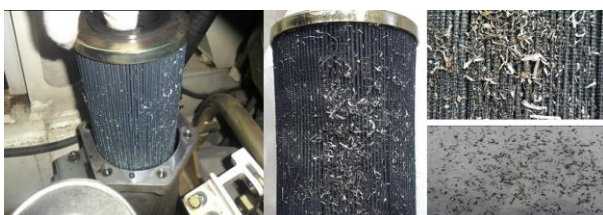
Fig. 1 Unidentified metallic foreign substances observed during annual maintenance

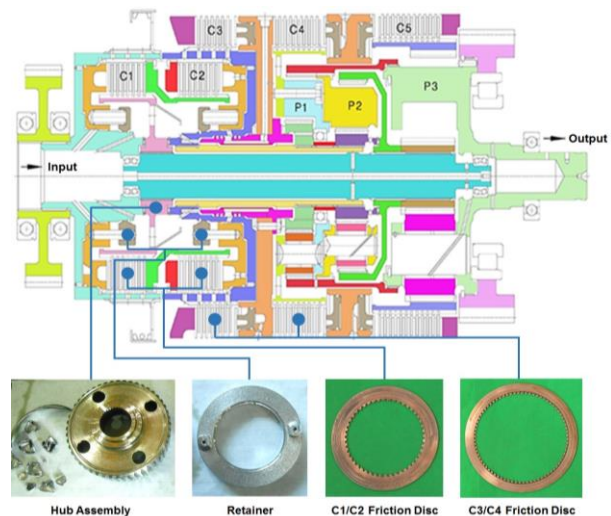
After the transportation of the transmission from the field military base to the ROK Army Consolidated Maintenance Depot, it was found that the hub assembly (Steel) for the C1 clutch in the range pack of the transmission was destroyed by carrying out the phased disassembly and inspection. Therefore, secondary damages to the surrounding parts, such as the retainers (Aluminum) and friction discs (Copper), were expected because the parts made of steel are generally harder than those of aluminum or copper. The damaged parts were observed in the range pack of the transmission, as shown in Fig. 2.

Fig. 2 Locations of damaged parts found in the range pack of the transmission by phased disassembly and inspection

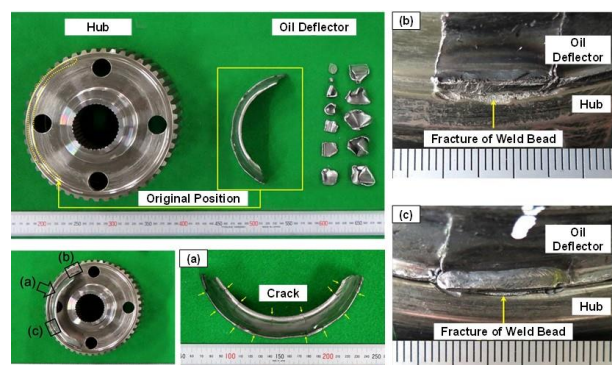
The hub assembly for the C1 clutch is fabricated into an assembly in which the hub and oil deflector are welded together. The destroyed hub assembly

was completely separated into the hub and oil deflector, and the oil deflector was also broken into several pieces, as shown in Fig 3. The primary and secondary damaged parts were analyzed in order to investigate the root cause of failure, and a large amount of metallic foreign substances collected in the oil filter was also analyzed.

Fig. 3 Destroyed hub assembly separated into hub and oil deflector

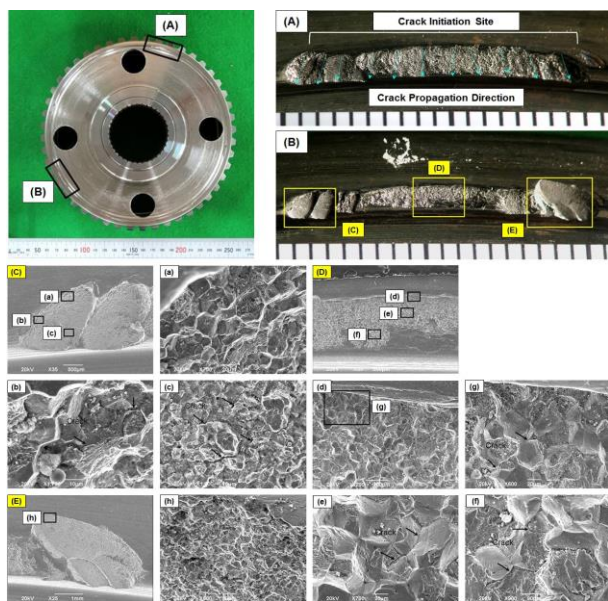
In the tests and analyses of the damaged parts, no discrepancies with the requirements in the military drawings were found. As a result of observation of the fractured surfaces by macroscopic and microscopic methods, the typical characteristics of fatigue fracture such as beach marks and striations were not observed. Because of the inter-granular fracture mode observed at the fractured surfaces of the hub assembly, as shown in Fig. 4, catastrophic fracture was expected due to the action of unknown instantaneous external force larger than the allowable load. In the EDS analysis results of the metallic foreign substances, it was found that steel, aluminum, and copper compositions were detected. Therefore, it was expected that the substances came from the damaged parts, such as the hub assembly, retainer, and friction disc.

Fig. 4 Macroscopic and microscopic observation of the fractured surfaces of the destroyed hub assembly in the range pack of the transmission

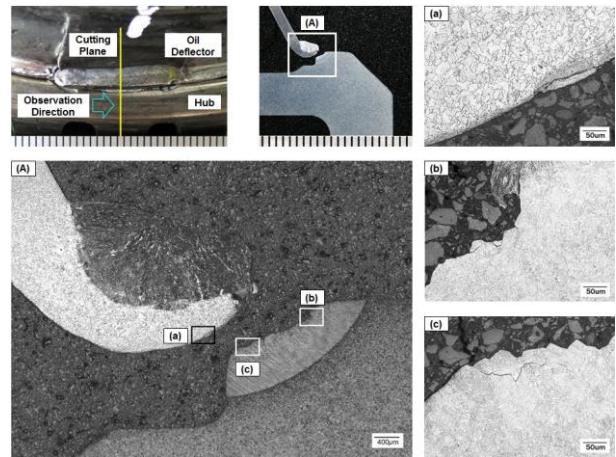
The observation results of the welding heat-affected zone (HAZ) of the destroyed hub assembly revealed typical hydrogen-induced cracking similar to that in the literature [3], as

Fig. 5 Macroscopic and microscopic observation of the fractured weld bead of the destroyed hub assembly in the range pack of the transmission

shown in Fig. 5. In addition, a similar result was observed in the welding HAZ of the newly-manufactured hub assembly. Therefore, it was found that the manufacturing process should be improved to prevent recurrence in the future.

In order to prevent the recurrence of similar cases in the future, welding procedure specification (WPS) was designated, and pre-heating procedures were added before the welding process. In addition, the inspection standard and test report were revised so as to be subdivided into weld beads, and engineering change (EC) was carried out for updating and rationalization of the requirements in the military drawings, which was identified during the follow-up activities.
