Electromagnetic Testing Rod Cluster Control Assembly in Pressured-Water Reactor Power Plant

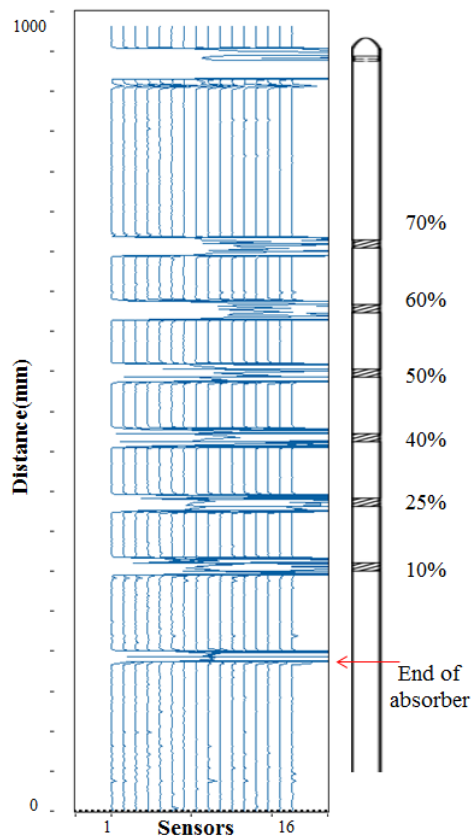
Fig. 2 shows the experimental results in waterfall graph of short circumferential grooves and sliding wears. The control rods have diameter of 9.68 mm and 0.47 mm thickness of cladding tube (STS304). The flaws depths are from 10%~100% of the tube thickness as indicated in the left side in each figure. The current supplied to the coil was 200mA-15kHz. The results show that all the short circumferential grooves from 10% depth were inspected.

Fig. 2 Inspection results of short circumferential grooves
