Cyclic Fatigue Behaviour of Impact-Damage for GFRP composites

J. I. Kim¹, Y.-H Huh^{1*}, J.H. Park² and Y. H. Kim³

¹Division of Industrial Metrology, Korea Research Institute of Standards and Science, Daejeon, South Korea

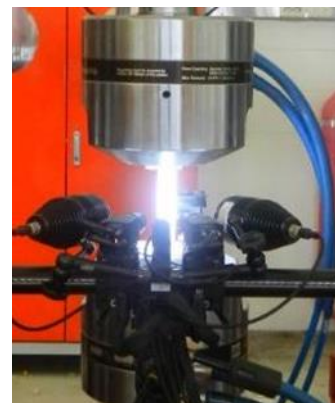
Fig.1 Experimental setup for cyclic fatigue load test and DIC measurement

Tensile and fatigue load were applied to the impact damaged specimens using servo-hydraulic machine (MTS810), as shown in Fig. 1, and fatigue loads were imposed on the specimen at a frequency of 3 Hz and with load control.

Stress distribution around the respective impact damage was measured by DIC(Digital Image Correlation) measurement.
